# Safety Inspection Report

Post-installation Inspection

## Great Maplestead Playing Field Play Area

28 March 2023

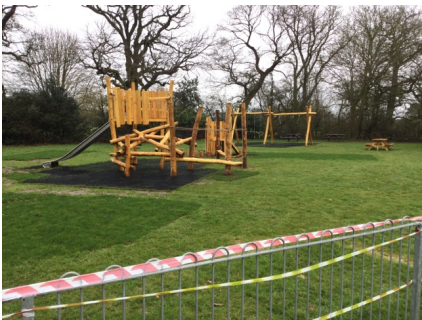
| Description |
|---|
| Dog ban & ownership signs recommended. |
| Ownership signs and dog ban signs are recommended. |

| Description |
|---|
| See <a href="https://www.rospace.com/play-safety/advice/signs">https://www.rospace.com/play-safety/advice/signs</a> |

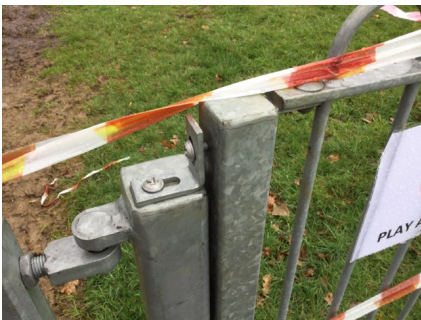
| Description |
|---|
| Bolt(s) loose. |
| Tighten all loose fence panel bolts. |

| Description |
|---|
| Tighten. |

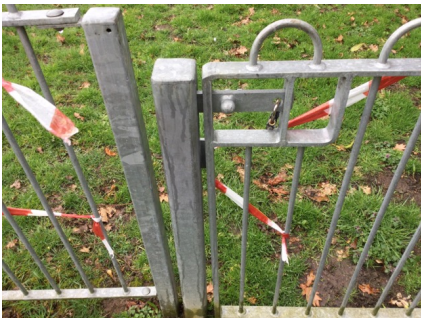
There is a crushing or shearing point on the side of the gate. Where the gaps reduce to less than 12 mm these have been known to cause serious, permanent injury to children, especially on the hinge side where the leverage forces are significant.

Adjust gate / posts / fit new rubber buffer to ensure a spacing of at least 12 mm throughout the range of the gate to remove the entrapment. The 12 mm gap also should apply on the hinge side of the gate.

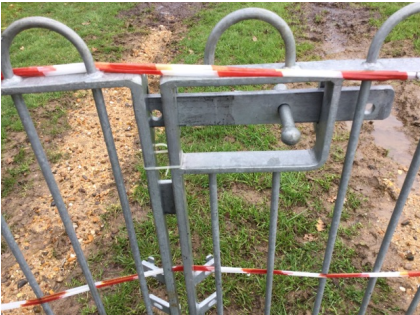
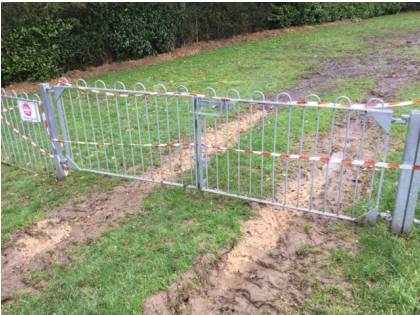
Maintenance gate should be locked at all times. Temporarily cable tied.

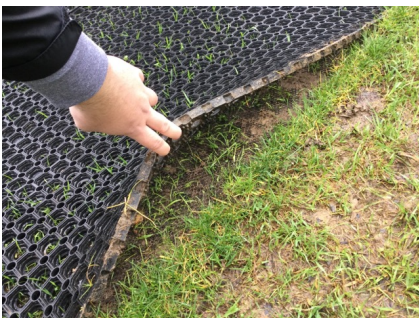
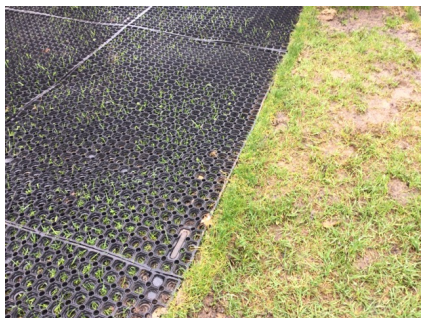
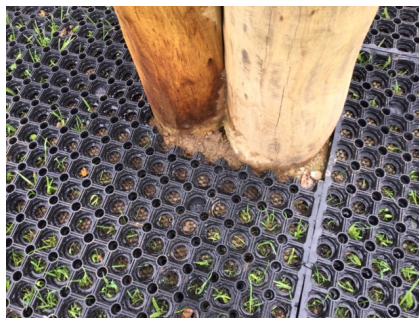
Surface needs repair.

Grass matting throughout the play area has not been pegged down around edges / supports and covered over allowing the matting to lift and create trip points.

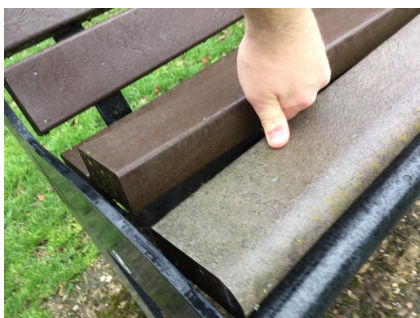
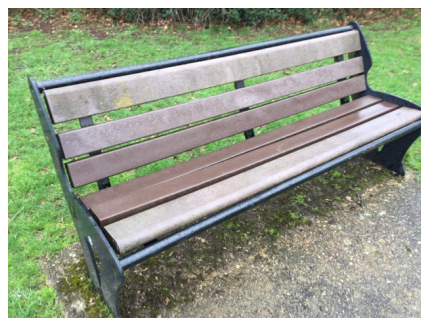
Fixtures loose or missing.

Fixings are missing on bench slats.

Replace.

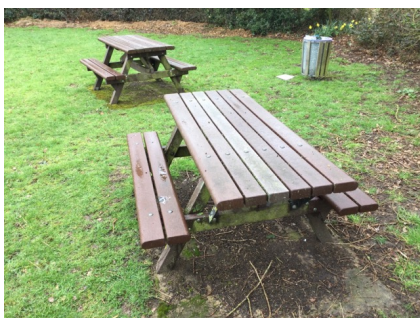
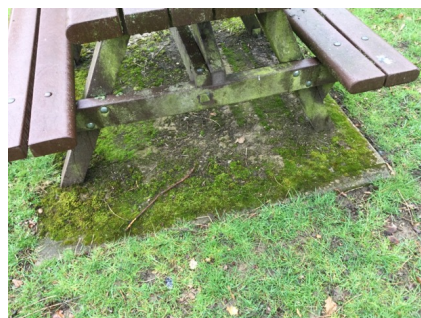
The equipment is dirty or algae covered.

Older plastic picnic tables. Remove surface moss.

Clean off.

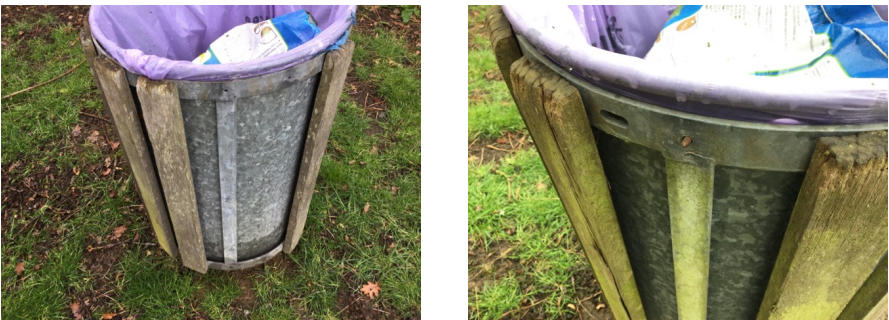
Item has some parts missing.

Timber slats are missing leaving projecting screws. Replace.

Replace the missing parts.

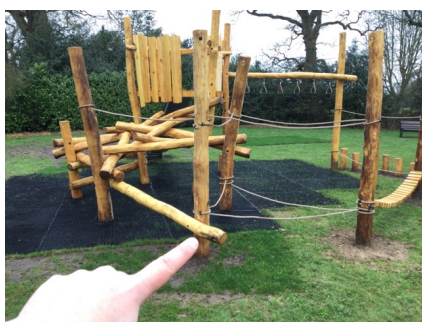
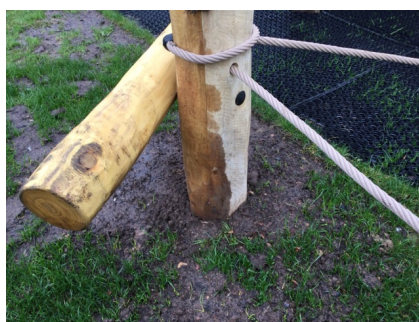
Loose in ground.

Rope walk / balance beam support is slightly loose in the ground providing excess movement when in use. Consider resetting.

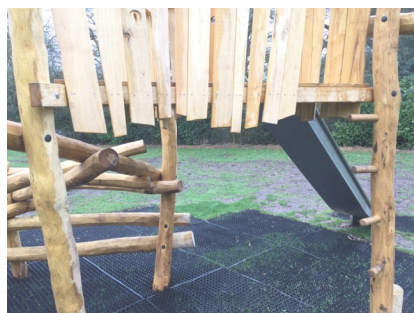
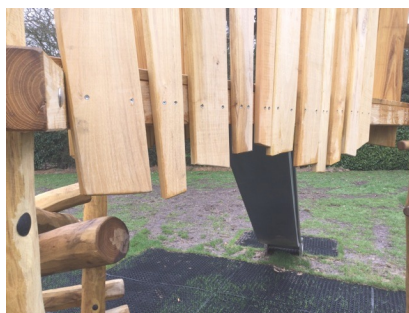
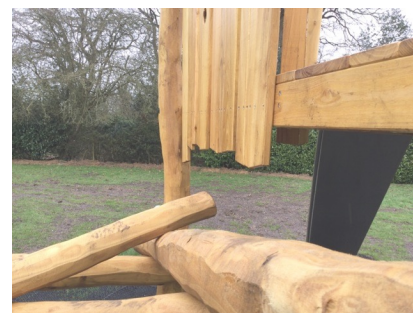
Underside platform slats could potentially cause a scraping injury to a unaware user. Consider removing surplus timber sections.

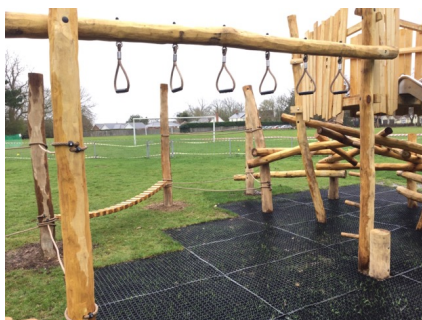
RoSPA is concerned by accidents on some types of overhead ladders and rings. However, there is a strong development value in these items.

The protective surface under all bars and rings must be kept in good condition.

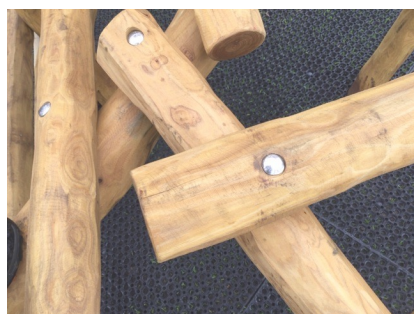
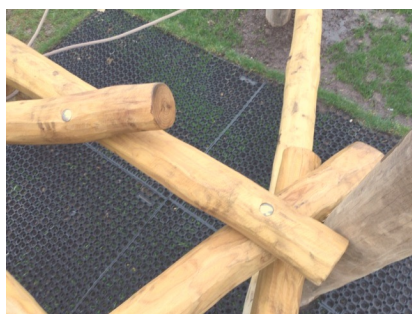
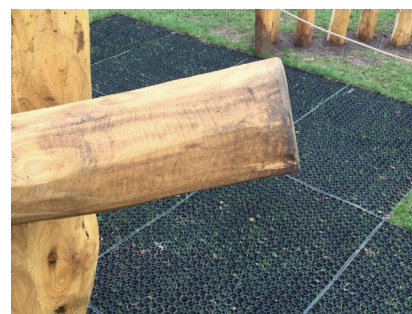
There are natural splits / shakes in the timbers.

Monitor all natural timber shakes close to fixings as they may work loose and regular tightening may be required.

Monitor and sand back any splintered edges as required., Shakes vary. Monitor and consult manufacturer if dimensions exceed 8 mm at sections used to grip / grasp.

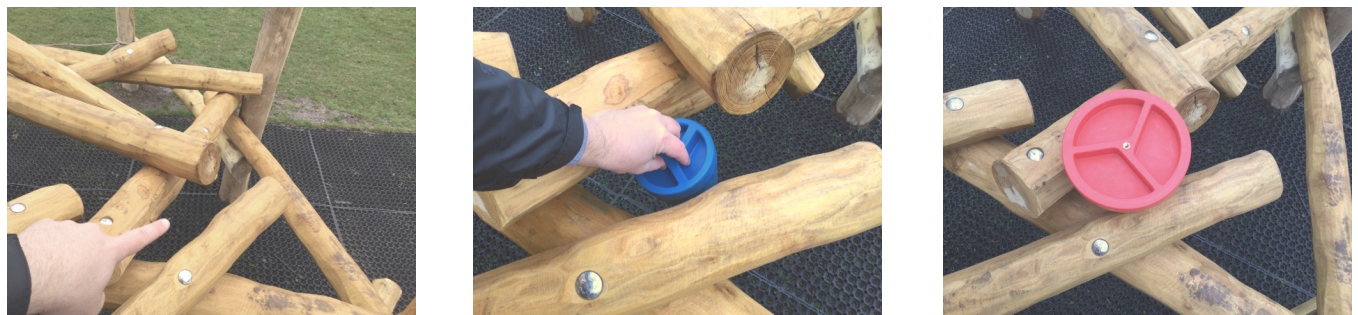
There is a head entrapment.

Balance beam cluster openings.

Modify.

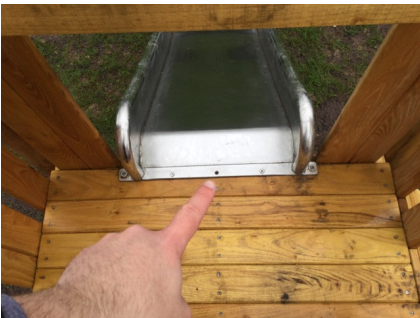
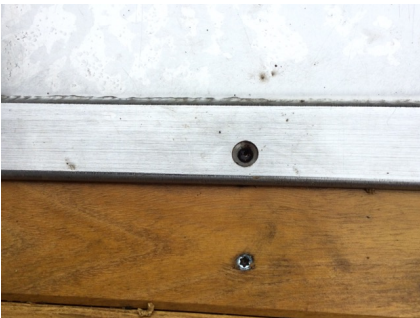
Slides starting section bolt is missing in the centre due to the platform fixings being in line with the bolt. Monitor slide for any loosening throughout the year and tighten when necessary.

Monitor.
